Infrared thermography for the building industry

Infrared thermography, the perfect tool for building diagnostics

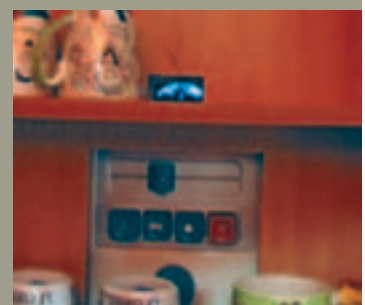
Gas heater built too closely to surrounding material provokes fire hazard

Thanks to infrared thermography, crevices, leaking joints and loosening stones in chimneys and exhaust sections of heating systems can be effortlessly discovered when they occur. Overheated locations, which can create chimney fires, become immediately visible on the infrared image. The danger of a fire due to building on too closely to hot heating and exhaust areas can also be recognized at once.
